Intel® Xeon™ Processor MP Specification Update

Release Date: March 2003

Order #: 290741-012

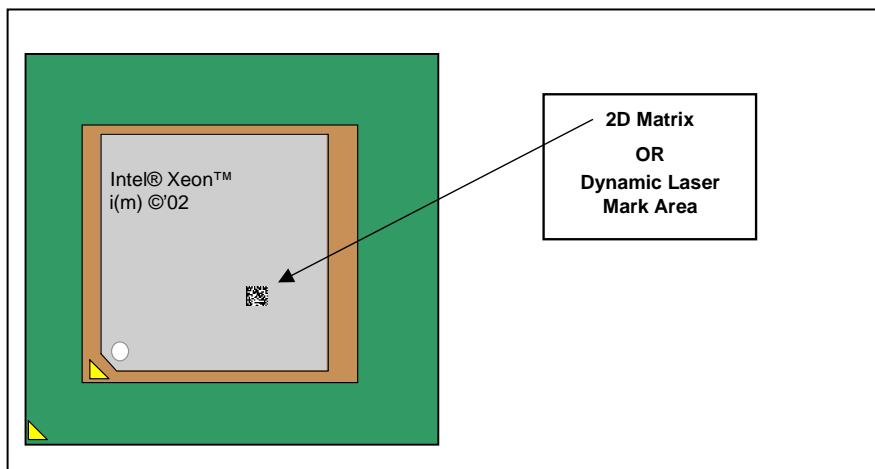
INTEL® XEON™ PROCESSOR MP and INTEL® XEON™ PROCESSOR MP WITH UP TO 2-MB L3 CACHE ON 0.13- MICRON PROCESS MARKINGS (603-pin INT-mPGA)

Figure 1. Top Side Processor Marking – Production Part

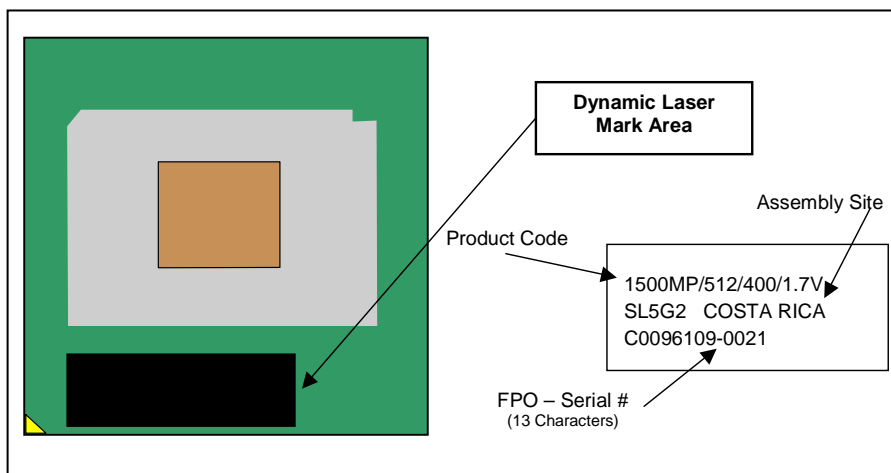
Figure 2. Bottom Side Processor Marking
